## Water Resources Department

May 21, 2013

### **Re: Big Creek Dams (B-28A and B) – Inspection Summary**

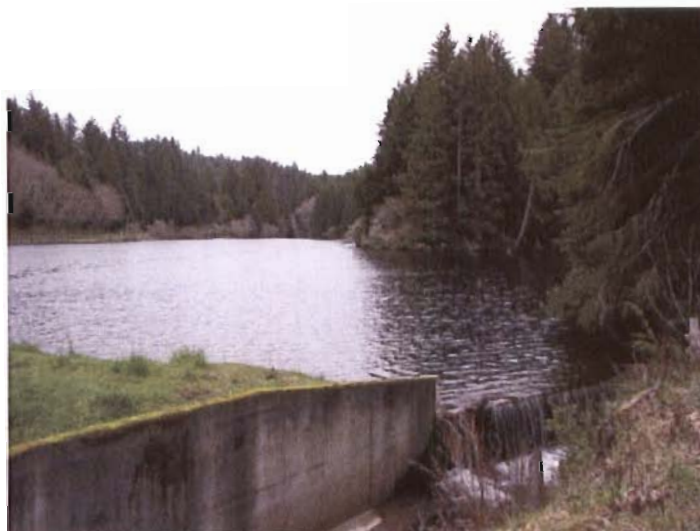
Spillway approach

The approach to the spillway is generally clear. There were no logs or debris at the approach or in the reservoir near the dam. There is no log boom, so cleaning the reservoir after a major windstorm would be necessary to protect spillway function.

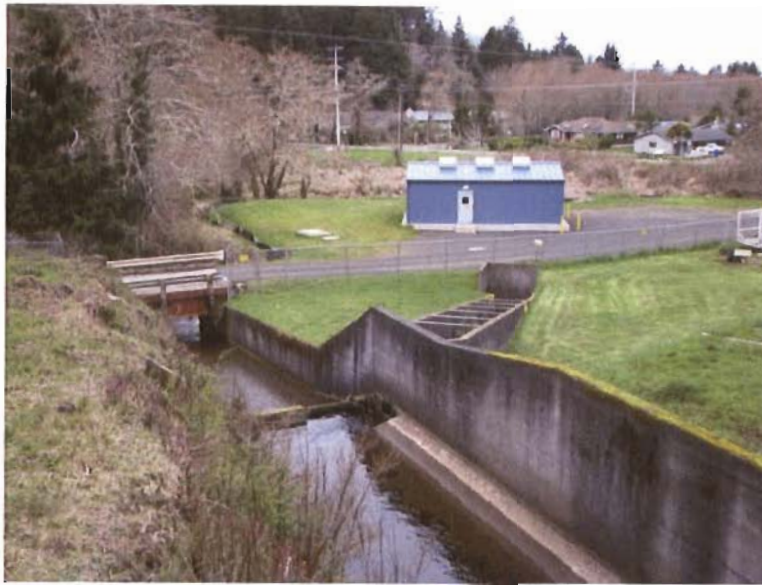
Spillway control and discharge with fish ladder

The concrete in the control section and down to the discharge was examined. The spillway shows no distress and appears fully functional.

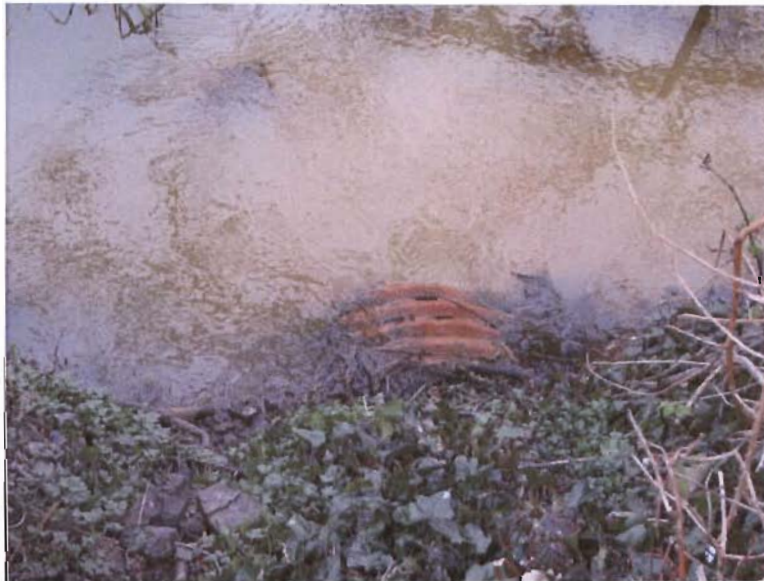
Discharge of low level conduit

I did receive designs for the new conduit from Civil West Engineering. However, they had no information on the current gate structure or trash rack. The plan is to install a 24 inch HDPE liner, with grouting of annular spacing. This is a short term priority for the dam, as is installing an effective gate for this low level conduit.

- 1) Watch the small seep in the middle of the dam, and notify me if flow becomes measurable.
- 2) Notify me when the conduit is repaired and ensure repairs address the gate and provide a likelihood of continued operation after an earthquake.

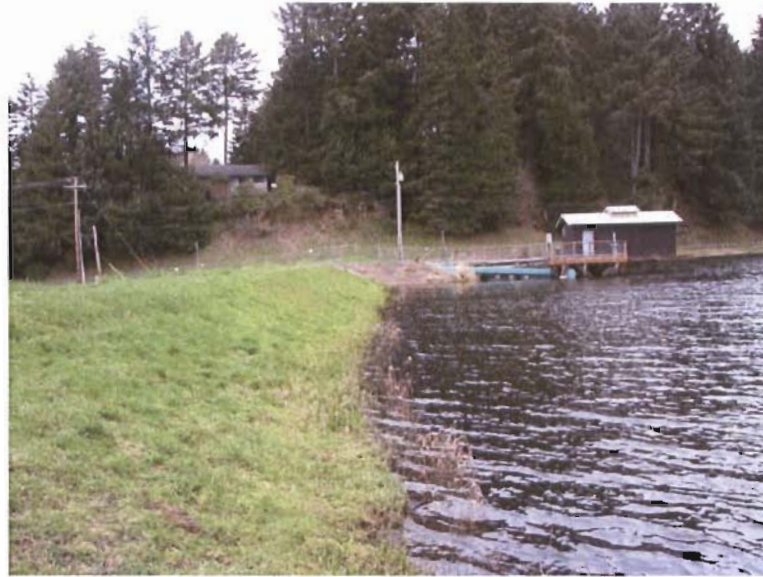
Upstream face and control works

The upstream face has a full cover of grass, and shows no signs of wave erosion or other distress. Minimum freeboard was 5 feet, which is very good for a 21 foot high dam. There is no significant debris in the reservoir.

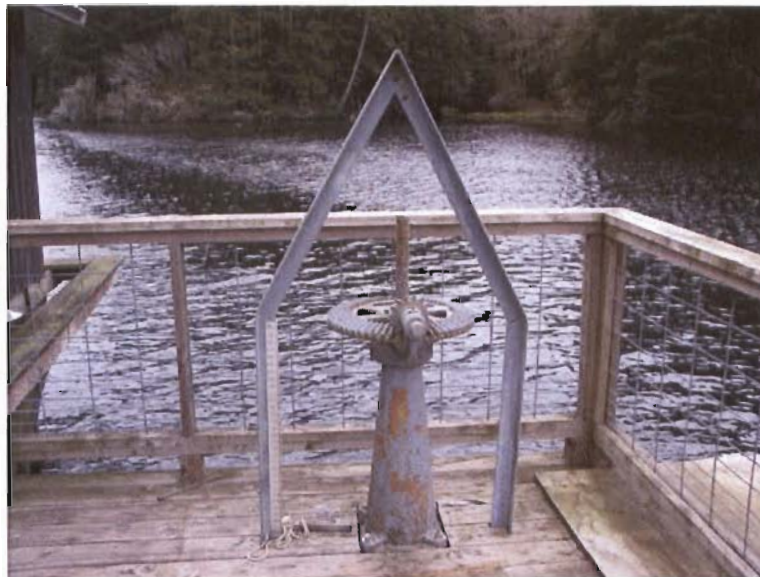
Control stem

This control stem may be very important in a seismic event. At the present time, I am unsure of its condition or operation. It is very important to ensure this structure is robust and functional during the work to re-line the low level conduit.

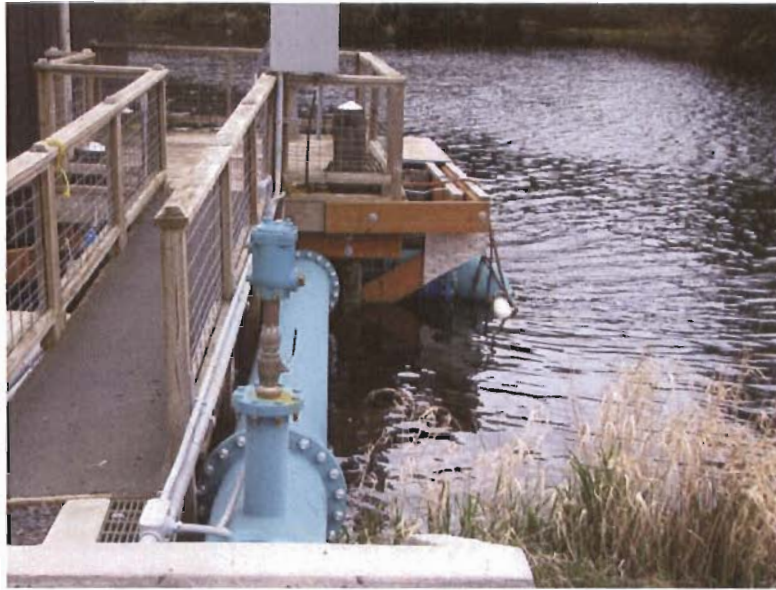
Intake to water treatment plant

This is the intake structure for the water treatment plant. Improvements to this structure necessitated the geotechnical boring and are the reason the seismic issues were discovered. The previous inspection of this dam was conducted during the borehole drilling and seismic cone penetrometer testing.

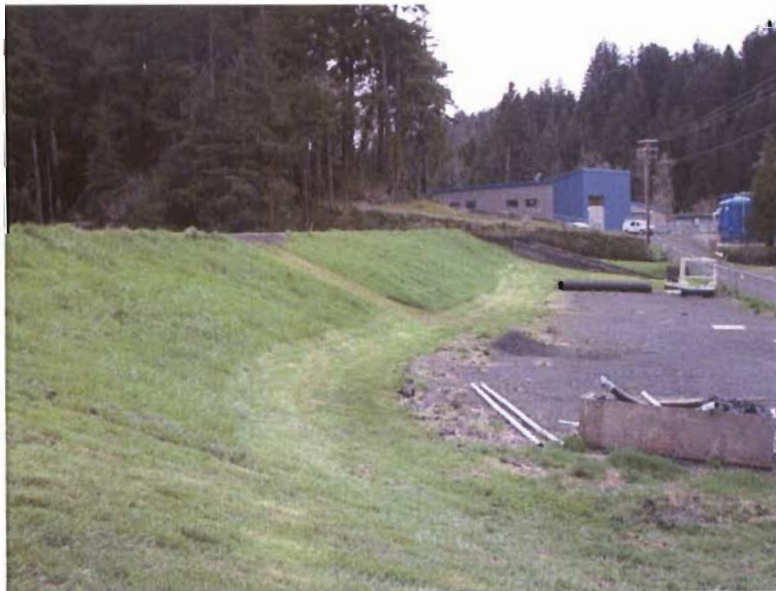
Downstream face

There is a dense cover of grass effectively preventing erosion on the downstream face of the dam. There is no woody vegetation growing on the dam or on the abutments. The toe of the dam is covered by a large berm which appears to be quite important to the seismic stability of the dam. Seismic stability is still marginal even with the berm, however.

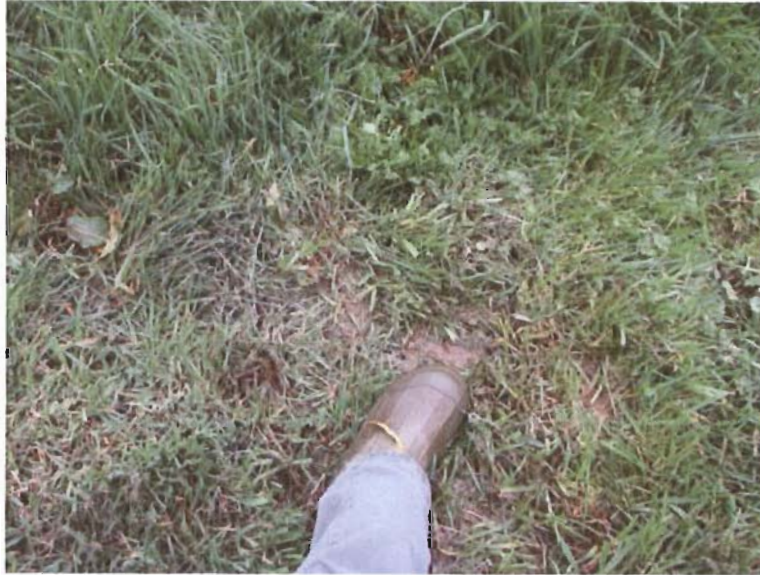
Small area of seepage

The wet area above was just above the toe of the dam, near the center. There was no measurable flow, and for now it is just a watch issue. I will reexamine this site the next time I am at the lower dam.

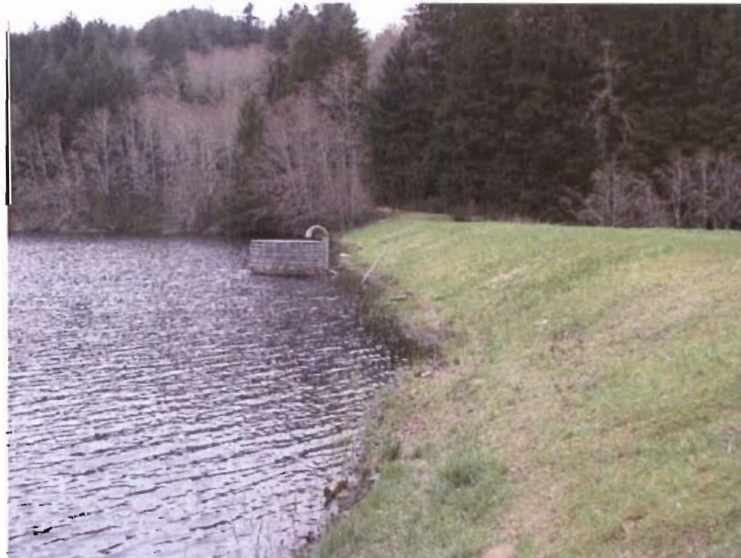
Upstream face and spillway intake

Upper Big Creek dam has a reasonable grass cover on the upstream face and crest. These locations show no signs of significant wave erosion or any movement. The dam had a minimum of 8.5 feet of freeboard for the past winter, which is also very good.

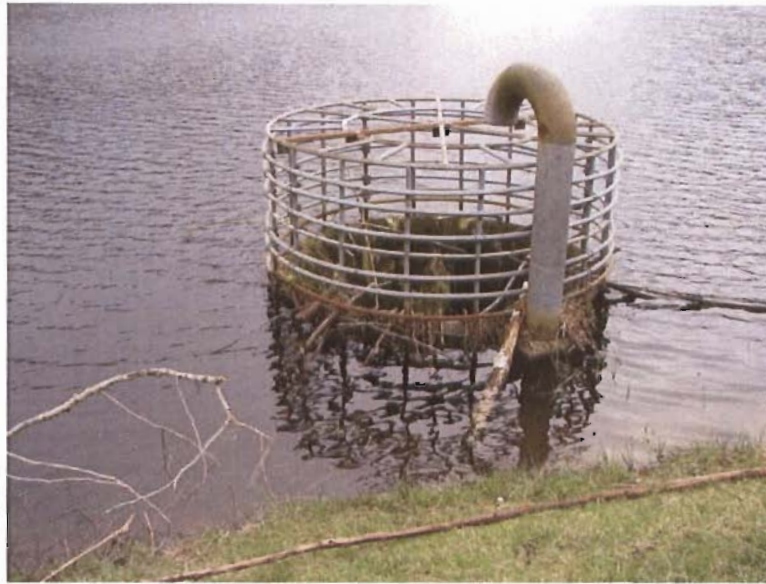
Trash rack for morning glory spillway

The principal spillway is a morning glory structure. The trash rack for this structure has a small amount of debris on the grates and floating around the structure.

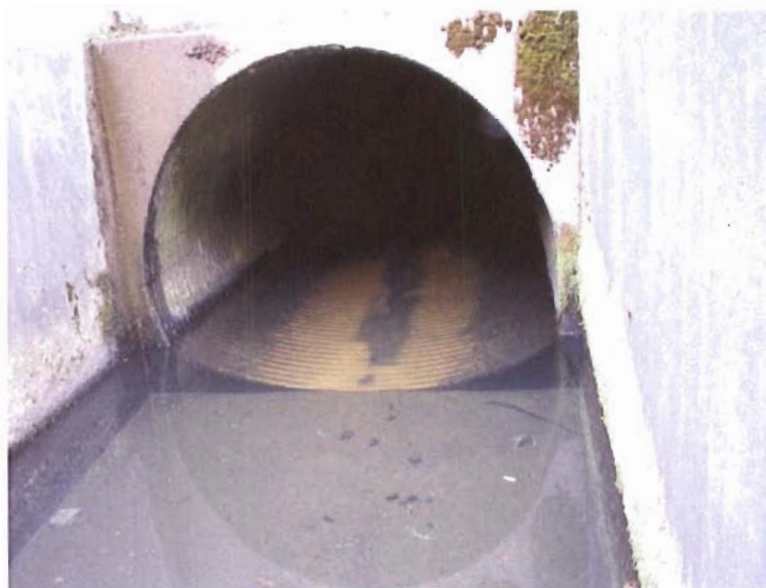
Outlet of principal spillway

The spillway conduit is a corrugated metal culvert. There was no significant corrosion observed in the culvert but it was only viewed from outside. A view inside this culvert will be attempted during the next routine dam inspection.

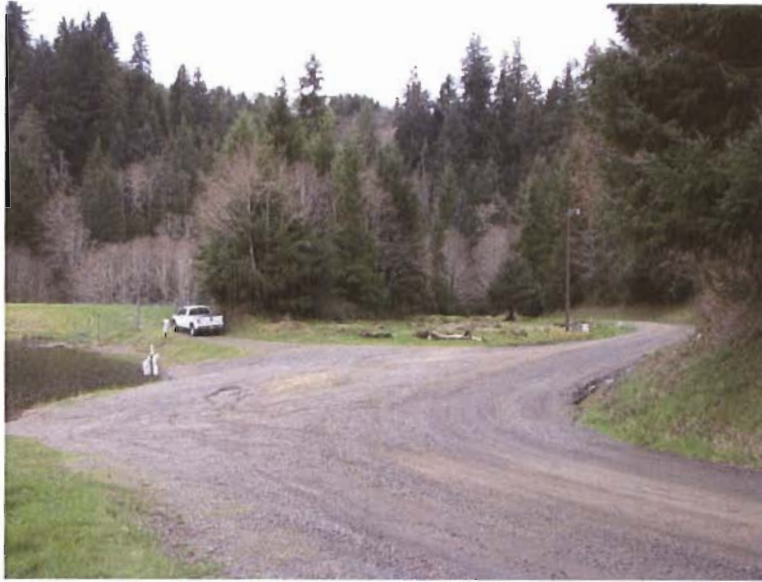
Emergency Spillway

The access road serves as a functional emergency spillway for Big Creek # 2 dam, and appears to provide more spillway capacity than the lower dam's spillway.

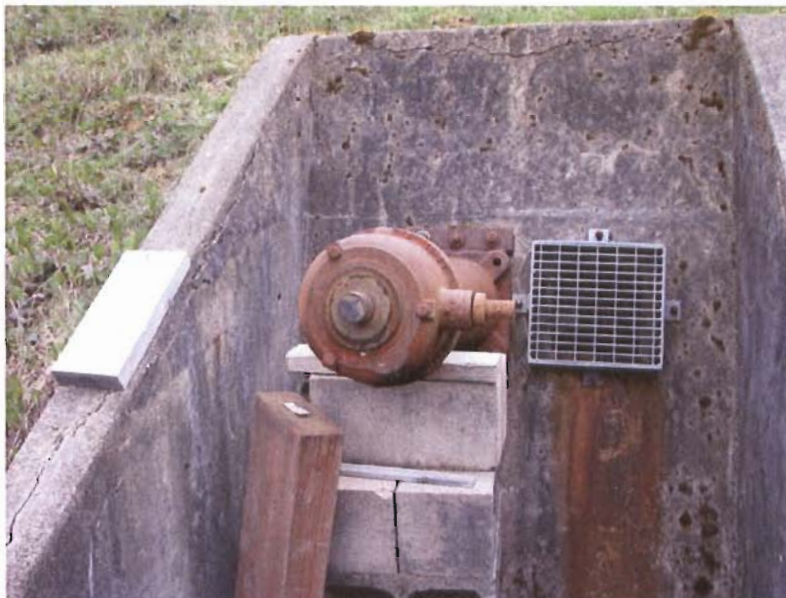
Control stem with air vent

The control for the low level conduit is supported by an unorthodox and unsecure combination of concrete blocks and boards. It is not sturdy, especially if there is an earthquake. The control stem and structure are both rusty. A permanent and seismically resistant support is essential, in addition to maintenance. Operation of the low level conduit may be essential after an earthquake, with no time available for repairs.

- 1) Provide permanent support to the control stem and improve its maintenance.
- 2) Install a weir box to collect and monitor flow from the right abutment.

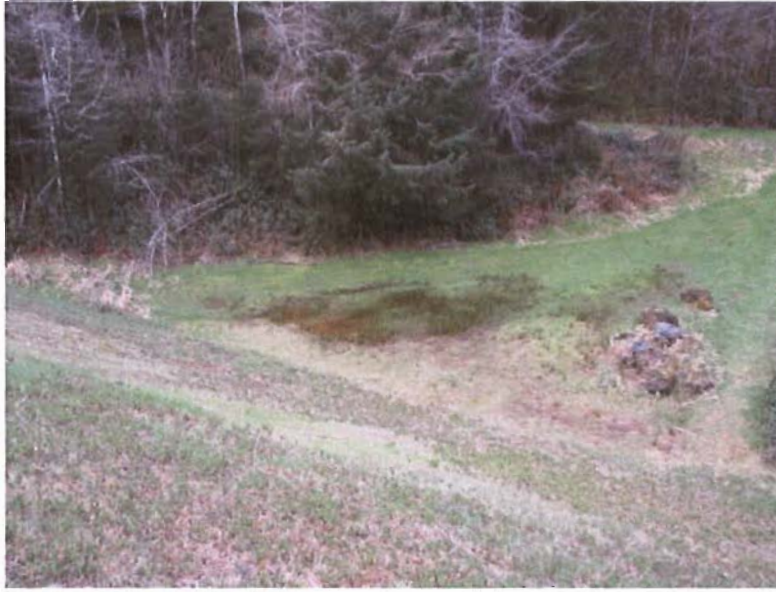
Wet area at toe of dam

The toe of this dam is wet for most of our inspections. I detect no change from inspections at similar water level, nor is there measurable flow leaving this location.

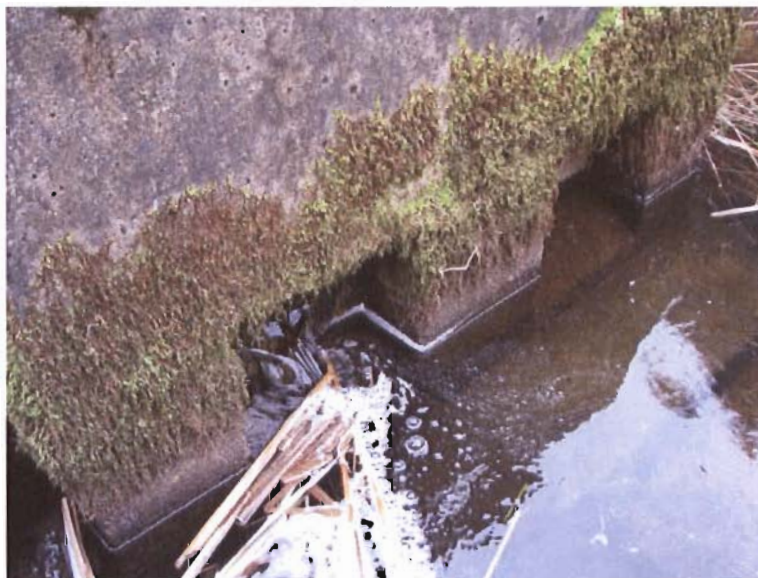
Toe drains

The toe drains seem to be functional. However, the weirs are generally not effective because of downstream high water levels or physical damage.

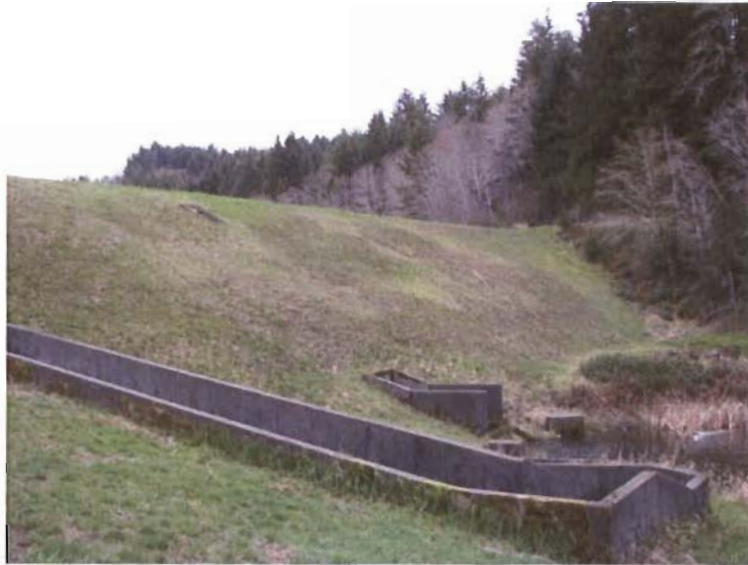
Downstream face with fish ladder

The downstream face was a little light on grass cover, but there was no erosion or signs of movement observed.

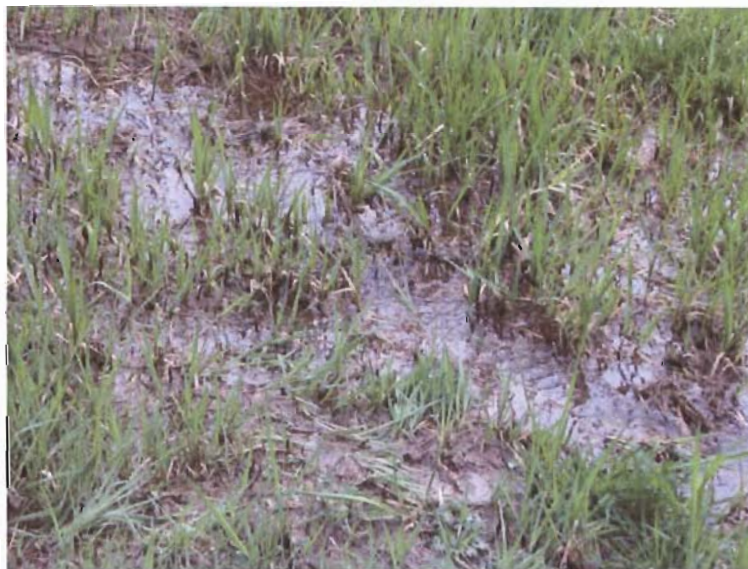
Area of seepage below right abutment

There is one area of seepage below the right abutment. It was also observed in the previous inspection. This seepage bypasses a weir box, as the culvert for that drain is mangled. There is enough water that it should be monitored with a weir box to see if the flow changes.
